Report No. CDOT-DTD-R-2004-2
Final Report

EVALUATION OF GFRP DECK PANEL FOR THE O'FALLON PARK BRIDGE

July 2004

**COLORADO DEPARTMENT OF TRANSPORTATION
RESEARCH BRANCH**

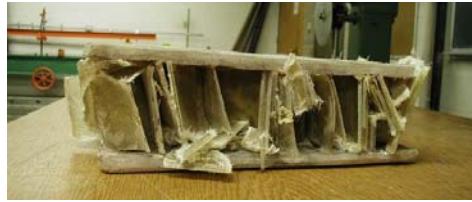
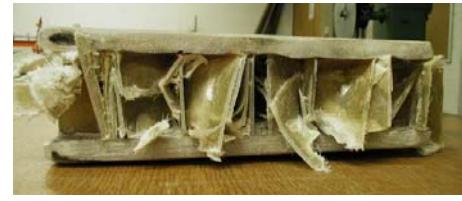
Figure 5-9 Crushing failure

All the specimens failed in the same manner. The specimens emitted the first noise between 35 and 70 kips, and visual observation indicated that the core walls started to buckle between 120 and 130 kips. The crushing loads are shown in Table 5-2.

The average crushing load was 162 kips with a standard deviation of 6.3 kips indicating a small scatter of results. Table 5-2 also shows the core crushing stresses calculated with equations (4.14) and (4.15). The average nominal and actual stresses at failure are 30% higher than those obtained by Lopez (2001). The specimens after failure are shown in Figure 5-9.

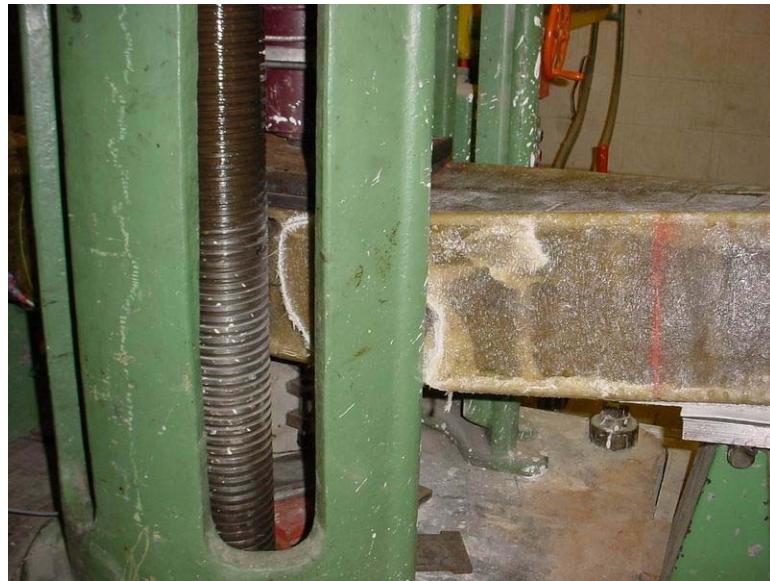
Figure 5-16 Failure mode in Test 1 – side view

During the test, several types of damage occurred. At about 25 kips, a first noise was heard indicating that some fibers were breaking. In fact, the load-strain curve from strain gage sg3 exhibits some nonlinearity at about 27 kips as shown in Figure 5-12. Throughout the rest of the test, noises were heard indicating that fibers were probably breaking continuously during loading. Inspection of the beam after failure showed the presence of loose fibers. Finally, at a load of 103 kips, the top face started delaminating. The failure was brittle and released a large amount of energy. Debonding between the core and the upper face started under the load and propagated outward along the top core-face interface as shown in Figure 5-16. After that, the top face debonded. The core was subsequently subjected to a larger load which caused the local buckling of the core at both sides of the beam as illustrated in Figure 5-17. After failure, the top face and the core were completely detached as shown in Figure 5-18.

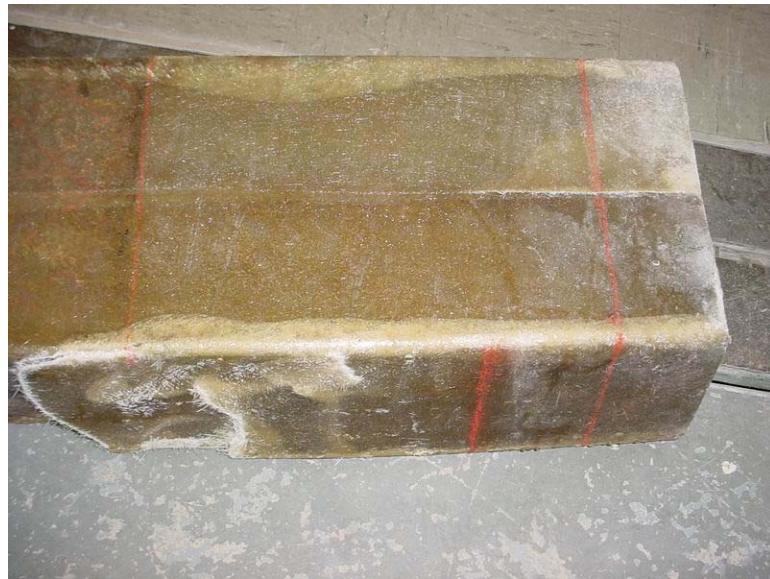
Figure 5-17 Local buckling of the core in Test 1

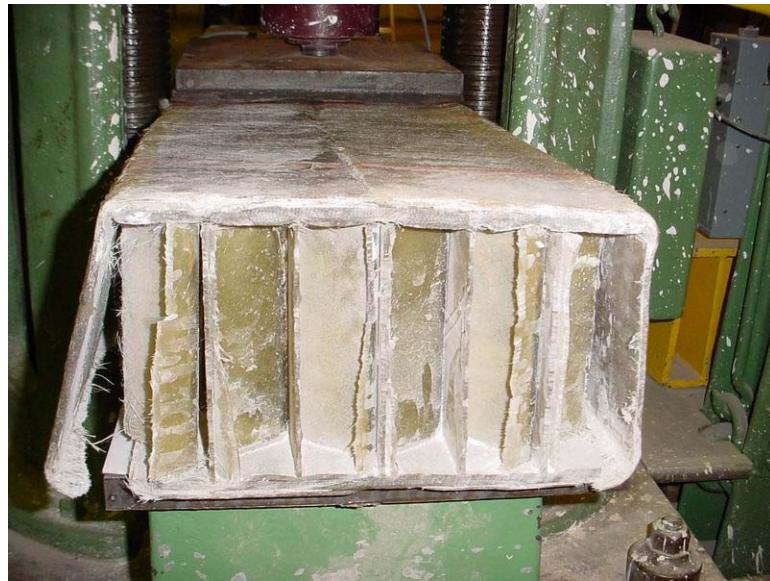
Figure 5-18 Failure mode in Test 1 – end view

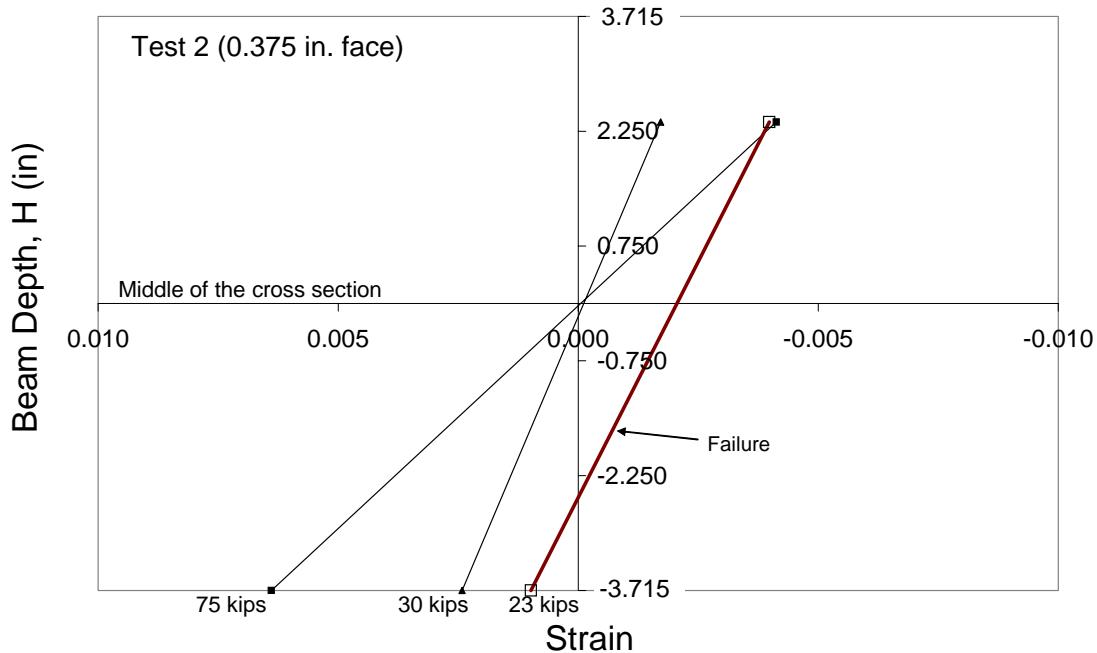
Figure 5-26 Strain profiles at different loading stages for Test 2 (midspan)

Figure 5-25 shows that the load-strain curve from strain gage sg6 is linear elastic up to failure. Figure 5-26 shows the strain profiles at midspan. After failure at 76 kips, the neutral axis shifted down indicating that the upper face had delaminated.

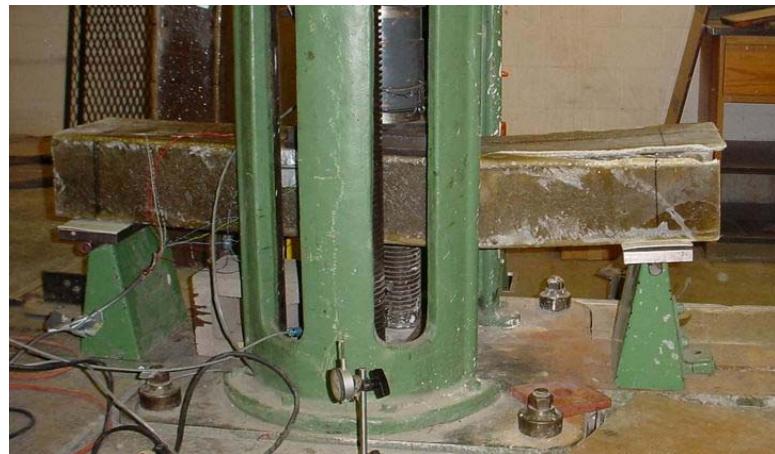
The failure in Test 2 was very similar to the failure reported in the first test. During the test, noises were heard indicating that some fibers were breaking during loading. At 75 kips, the load dropped slightly (Figure 5-19), probably because of a partial debonding between the top face and the core. Eventually, the partial debonding propagated and

triggered the brittle failure. At a load of 76 kips, the top face debonded. Debonding between the core and the upper face started under the load and propagated outward along the core-face interface as shown in Figure 5-27.

Figure 5-27 Failure mode in Test 2

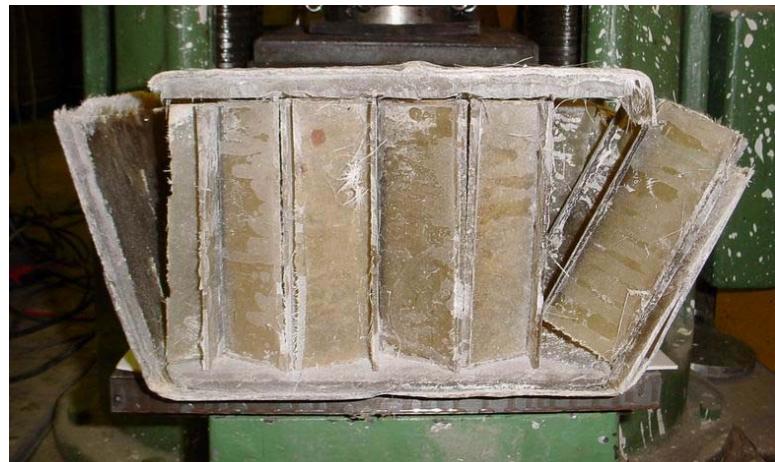
As in the first test, the upper face was completely detached from the core as shown in Figure 5-28. The lost of composite action caused the core to carry more load, and consequently, the core buckled locally as shown in Figure 5-29.

Figure 5-28 Debonding at top face-core interface in Test 2

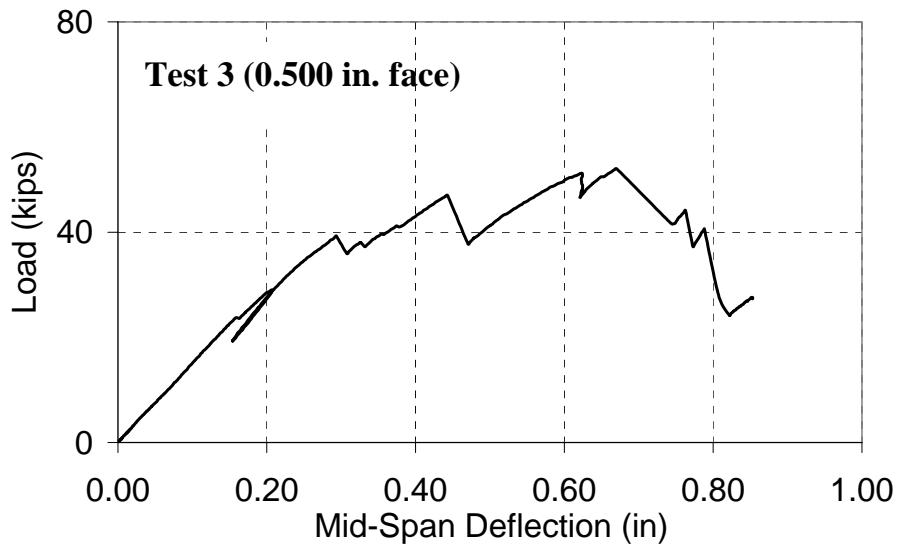
Figure 5-30 Load-deflection curve for Test 3

The load-displacement curve for Test 3 was linear up to about 23 kips as shown in Figure 5-30. At 23 kips and a deflection of 0.165 in, the upper face started debonding and the load-displacement curve became nonlinear. At 39, 47, and 50 kips, the load dropped suddenly indicating that the upper face continued to slip. This is well explained in Figure 5-31, which shows that, after the load dropped, the neutral axis at midspan shifted downward due to delamination of the top face. At 52 kips, the load dropped and the neutral axis shifted upward to the centroidal position, as shown in Figure 5-31, indicating that the bottom face slipped eventually causing the sudden failure of the beam.

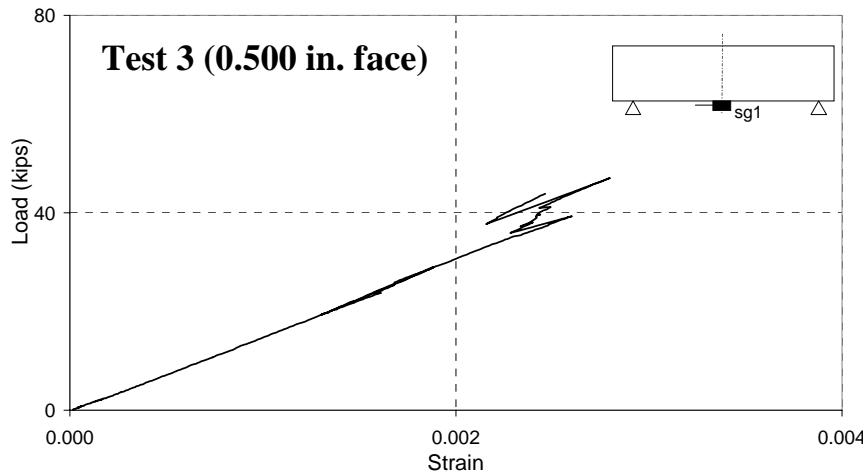
Figure 5-32 Load-strain curve for Test 3 (gage sg1)

The reading from the strain gage placed at the middle of the beam on the bottom face indicated that the face-core system lost the full composite action at 40 kips. This can be deduced from the sudden stiffness change in the load-strain curve in Figure 5-32. The

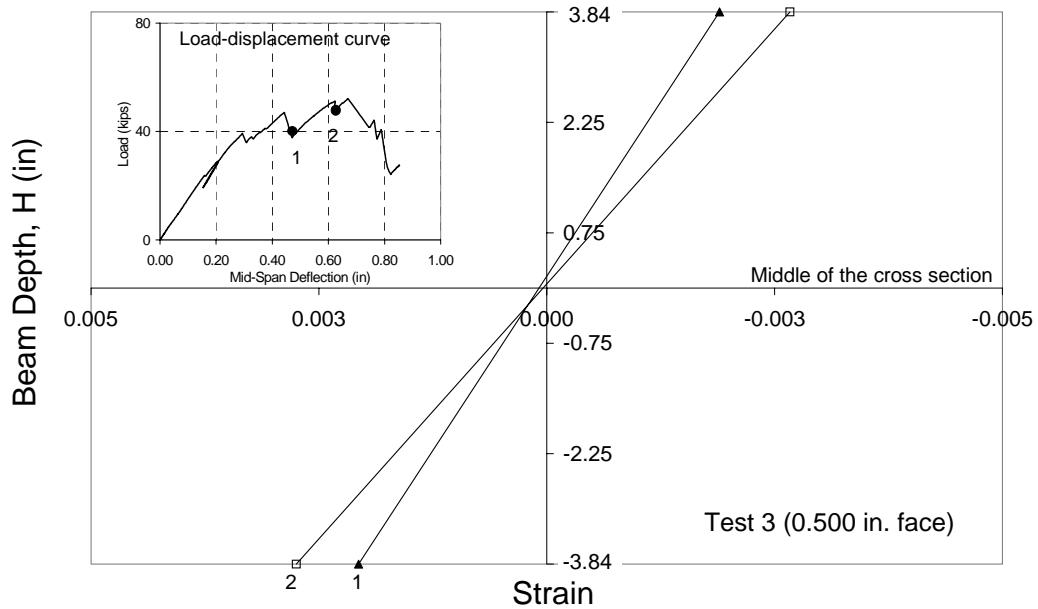
Figure 5-36 Strain profiles at different loading stages for Test 3 (sg3/sg4)

Up to about 39 kips, the load-strain curves for gages sg3 and sg4 show a constant stiffness, as for the gages sg1 and sg2. At the section where these gages were located, the neutral axis did not change position up to the peak load as shown in Figure 5-36. This indicates that, in the beginning, the slip was localized at the middle and, later, it propagated toward the end of the beam.

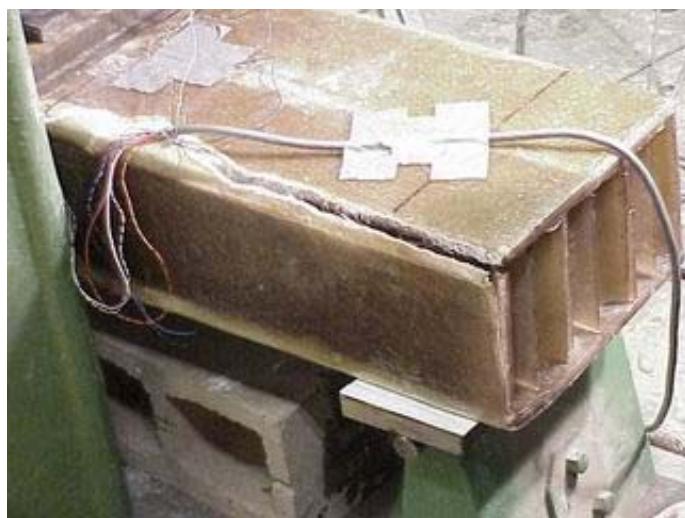
The failure observed in Test 3 was different from the failures reported in the previous tests. The beam failure was pseudo-ductile. The face debonded from the core progressively starting at 36 kips. The delamination started at the top of midspan and propagated toward the end of the beam. The top face did not debond uniformly and only the back side of the core buckled as shown in Figure 5-37.

Figure 5-37 Failure mode in Test 3

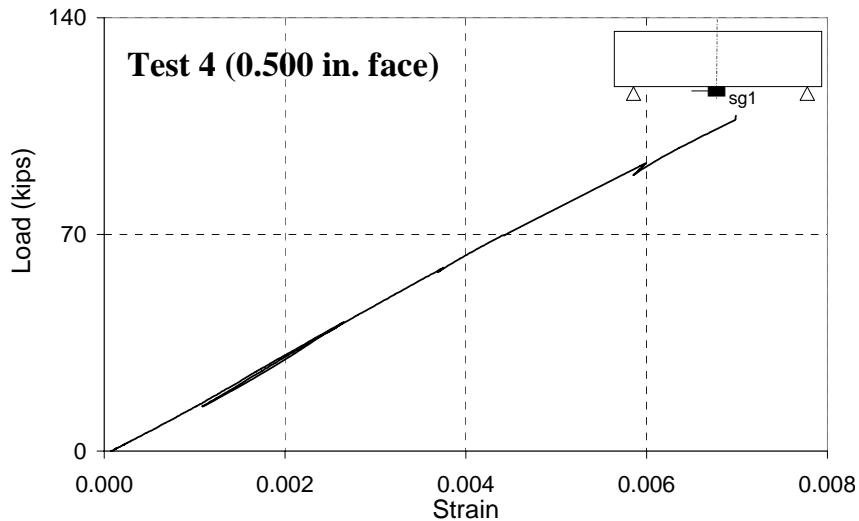
Figure 5-39 Load-strain curve for Test 4 (gage sg1)

The strain gage located at midspan under the beam indicated that the response was linear elastic up to 108 kips as shown in Figure 5-39. The gage probably failed at a smaller load level than the beam. This may be due to gage malfunctioning or a localized failure (some fibers might have broken at this location).

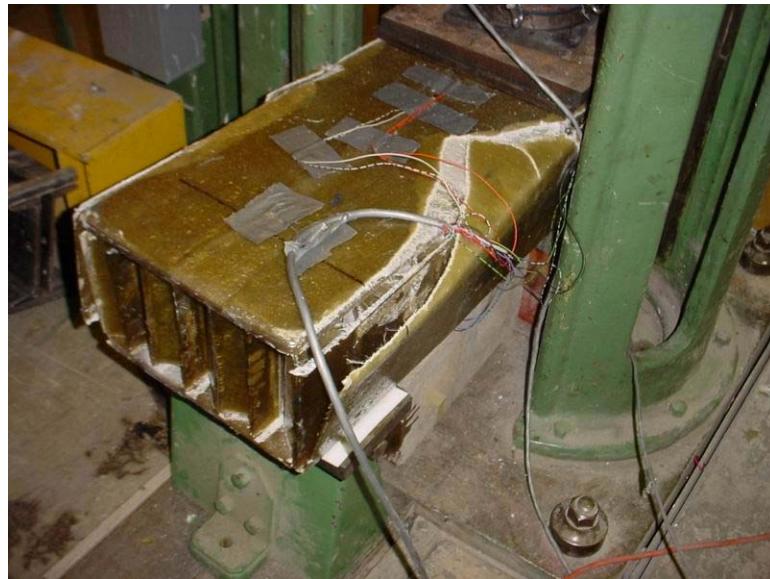
In Test 4, the first sound was registered at 20 kips, and noises were heard constantly thereafter at different loading stages indicating progressive damage (broken fibers). The load-displacement response was linearly elastic up to 108 kips. At about 108 kips, the top face started to debond from the core under the loading plate. The load-strain curve collected by sg1, located at midspan, became nonlinear at this load stage, while sg4 and sg6, located at 7.08 in. and 9.44 in. from midspan, respectively, did not register any stiffness change. The debonding process propagated from midspan toward the end of the beam eventually causing failure at 131 kips. After failure, both sides of the core buckled as shown in Figure 5-44. After failure, the top face was completely detached from the core as shown in Figure 5-45.

Figure 5-44 Failure mode in Test 4

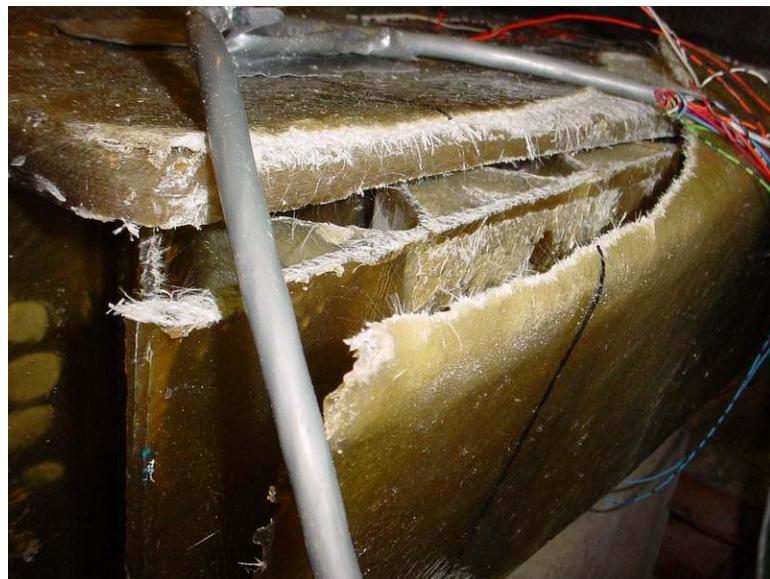
Figure 5-45 Debonding at the face-core interface in Test 4

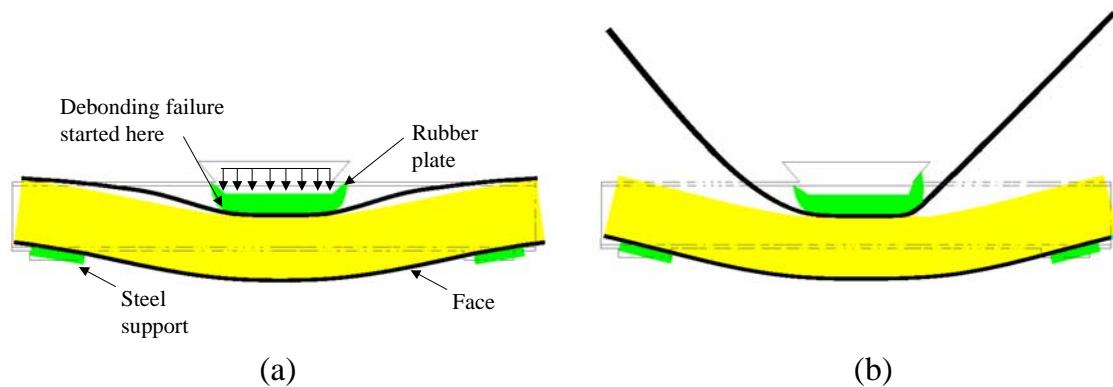
Figure 6-25 Deformed shape after failure (Amplification factor of 5)

Figure 6-25 shows the deformed shape at failure for Test 2. Debonding starts near the edge of the loading plate (Figure 6-25 (a)), and propagates toward the end of the

beam (Figure 6-25 (b)). This result matches the experimental observation.

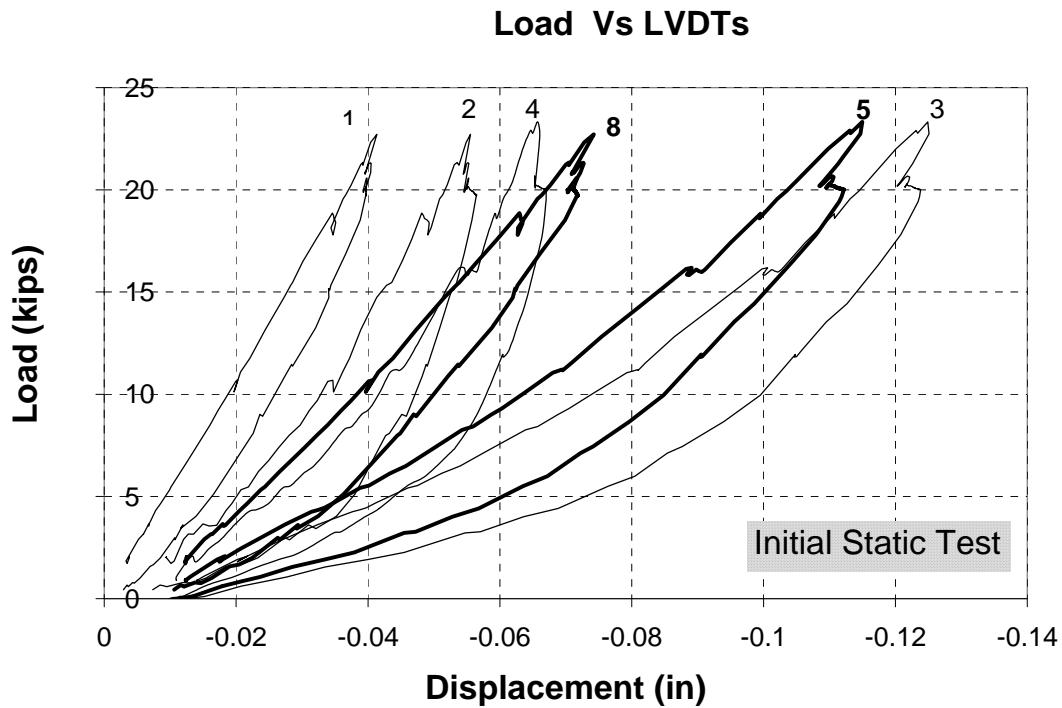
Figure 7-10 Load-displacement curves for the initial static test

The panel stiffness was difficult to determine from the test results because it was influenced by the settlement of the bearing pads. For this reason, one LVDT was placed near each support to record the displacement due to the settlement of the bearing pads. Figure 7-10 shows the experimental load-displacement curves from all the LVDTs placed along line C-C shown in Figure 7-7.

The anchor bolts on riser R₁ (see Figure 7-9) slipped during the test. Visual inspection at the end of the static test showed that the bearing pad placed on riser R₁ moved from the initial position. The pad rotated and left a gap between the riser and the panel at the location of line C-C, and this explains why LVDT 3 registered a larger deflection than LVDT 5. The deformed shape of the panel at 22 kips, drawn with AUTOCAD 2000 using the LVDT readings, is shown in Figure 7-11. In this figure, a Bezier curve is used to approximate the deformed shape and estimate the actual deformation of the panel. A Bezier curve is a simple cubic equation and was originally developed by Pierre Bézier in the 1970's for CAD applications. A cubic Bezier curve is defined by four points: (x_0, y_0) is the origin point, and (x_3, y_3) is the destination point, and (x_1, y_1) and (x_2, y_2) are control points.

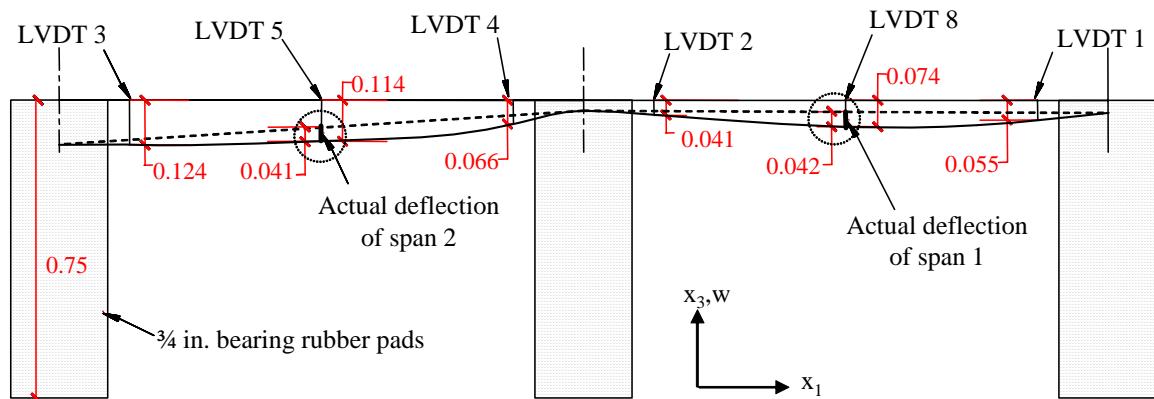
Figure 7-11 Deformed shape along line C-C (All dimensions in inches, deflections amplified 30 times)

All dimensions in Figure 7-11 are in scale, with the displacements in the x_3 direction amplified 30 times. The curve is forced to have a horizontal tangent at the center of the interior riser, R_2 , and it is used to estimate the bearing pad settlements at the supports.

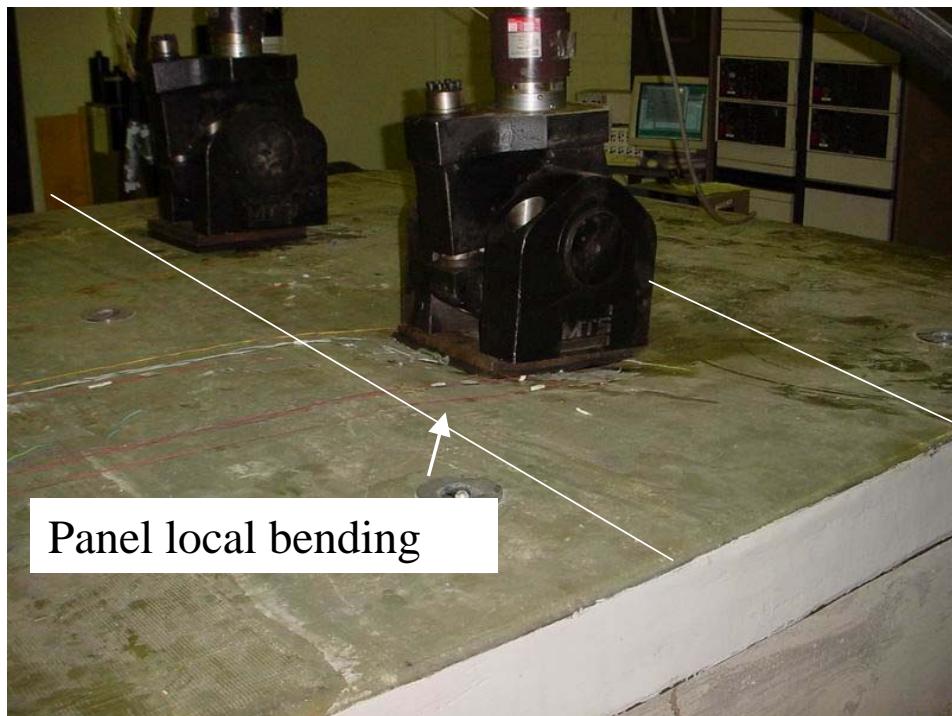
Figure 7-16 Picture of the panel local bending

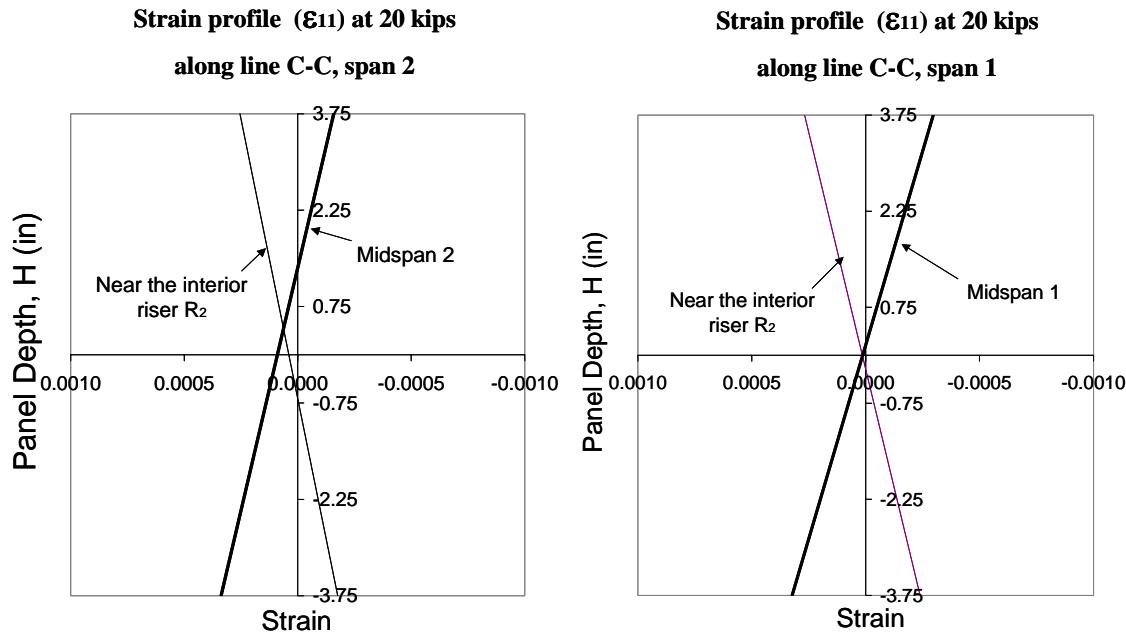
Figure 7-17 Panel strain profiles

The localized bending near the loading plate was observed clearly during the test as shown in Figure 7-16. Figure 7-17 shows the strain profiles along line C-C at 20-kip load and indicates that in Span 1, the neutral axis was at the mid-height of the panel cross section. However, in Span 2, the neutral axis was not at the mid-height of the panel section, but was shifted toward the upper face at the middle of Span 2 and shifted toward the lower face near the interior riser, R_2 .

Since no panel delamination was expected at this loading stage, the shift of the neutral axis was probably caused by the member tension exerted by the anchor bolts as the panel experienced excessive settlement at riser R_1 , as illustrated in Figure 7-18.

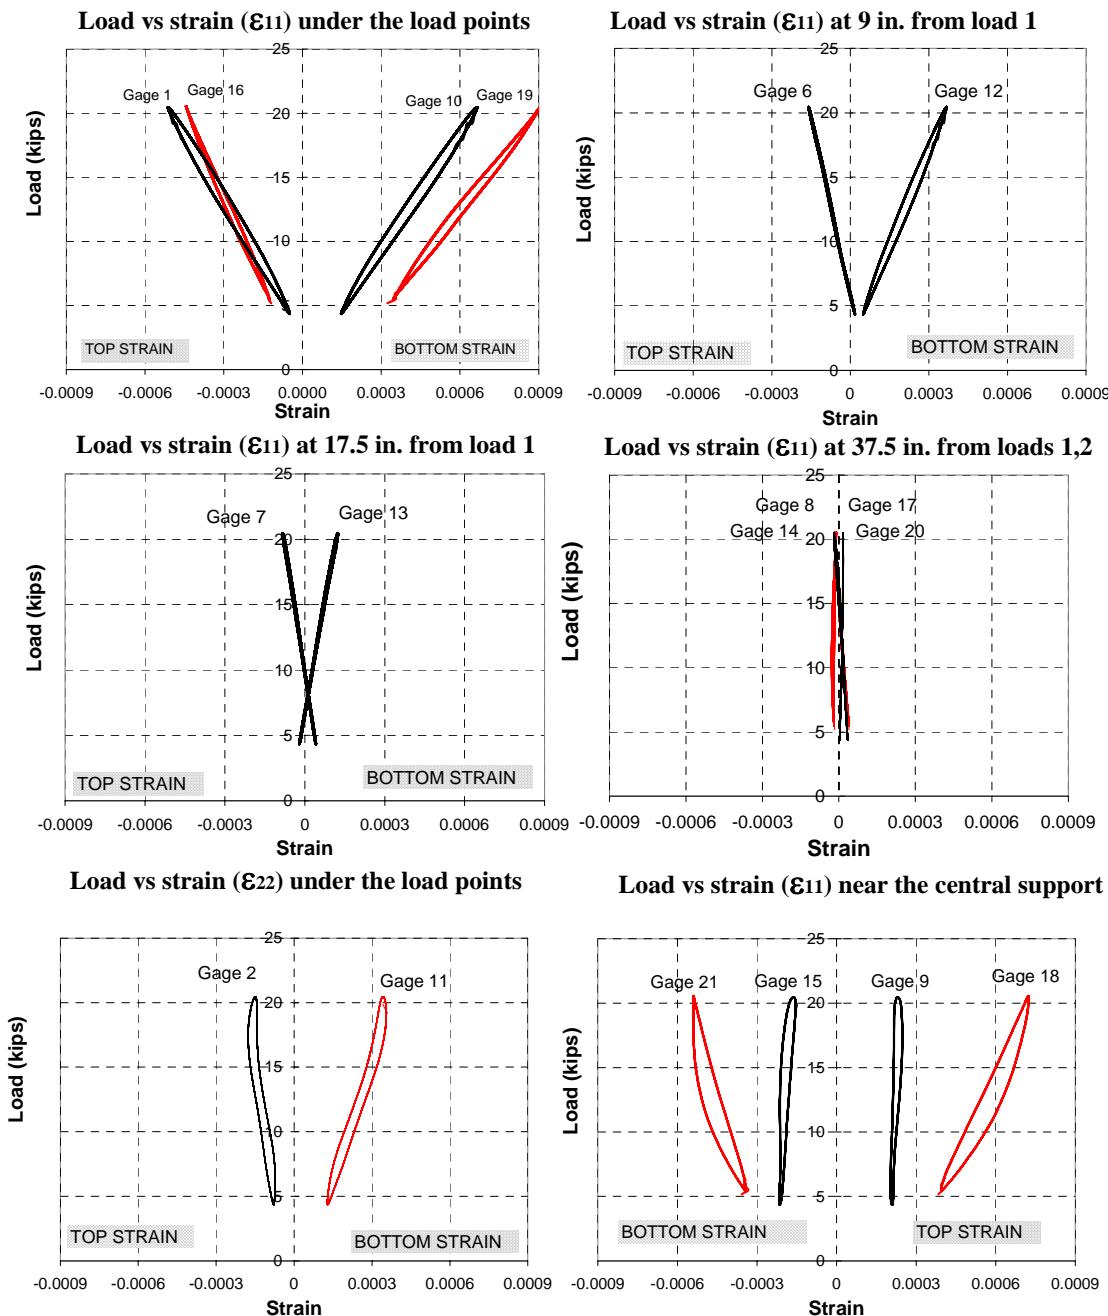
Figure 7-19 Load-strain curves for all the strain gages at 15,000 cycles

The two spans were loaded by two actuators with sine waves that were 180° off-phase and a maximum load of 40 kips in each actuator. At about 14,000 cycles, Span 2 started emitting a strong noise near the loading plate. Inspection of the panel did not show any external damage. The noise was very likely caused by the delamination of the upper face from the core. Between 15,000 and 15,200 cycles, data were recorded for 200 cycles (Cyclic data 1 in Table 7-2). The load-strain curves are shown in Figure 7-19.

Gages 16, 18, 19 and 21 glued on Span 2 show permanent deformation. Gages 16 and 19 were attached to the top and bottom faces of the panel right underneath the load in Span 2. Gage 19 showed a larger strain than gage 16. This was probably caused by the delamination of the top face. The gages glued at 37.5 in. from the loading point showed

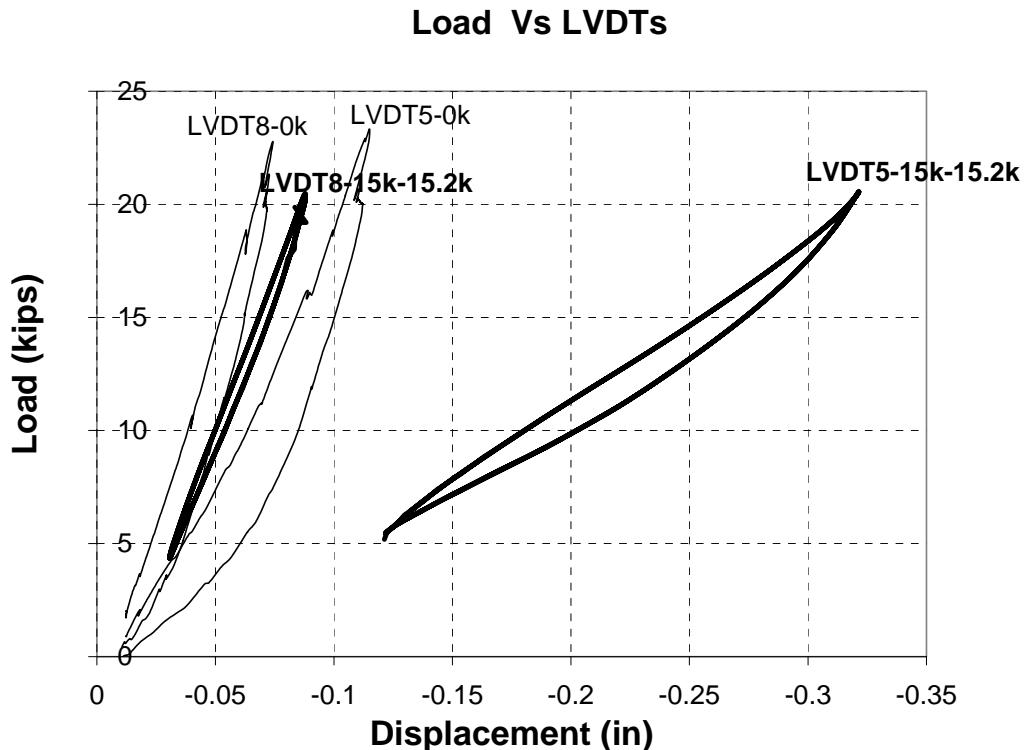
Figure 7-20 compares the load-displacement curves obtained from the midspan locations at the initial static test (0) and between 15,000 and 15,200 cycles. As indicated in Table 7-1, the loading schemes are different, and, therefore, the stiffnesses cannot be compared directly. However, LVDT 8 showed similar results at the initial static test and between 15,000 and 15,200 cycles, while LVDT 5 indicated a much larger deformation between 15,000 and 15,200 cycles than at the initial static test. This is probably due to the delamination of one of the faces from the core in Span 2.

Figure 7-20 Comparison of the load-displacement curves at the initial static test (0k) and between 15,000 and 15,200 cycles

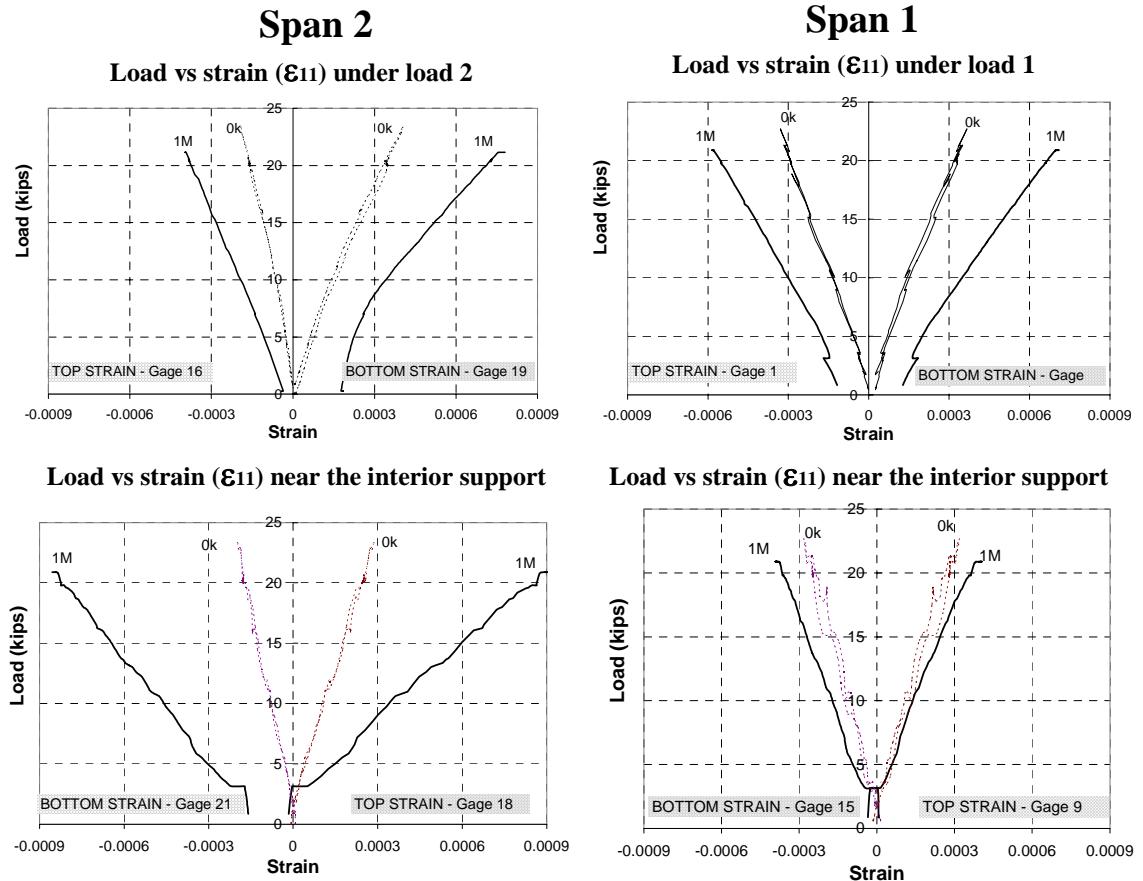
At 370,200 cycles, the deck was examined and no damage was observed. The loading of Actuator 1 was increased to a maximum load of 31 kips for subsequent cycles. At 1,000,000 cycles, the test was interrupted to perform a static test to evaluate the panel behavior (Static Test 1M in Table 7-2). To compare the results with those of the initial static test, both spans were loaded at the same time up to 20 kips. Figure 7-22 shows that the strains under the loading plates and near the interior support, R_2 , were larger at 1,000,000 cycles than at the initial static test for both spans under similar loads. The stiffness change is probably due to damage in the interface between the faces and the

core. In particular, in Span 2, the strain near the middle support (negative moment region) at 1,000,000 cycles is more than four times larger than the strain at 0 cycle.

Figure 7-22 Load-strain curves at 1,000,000 cycles

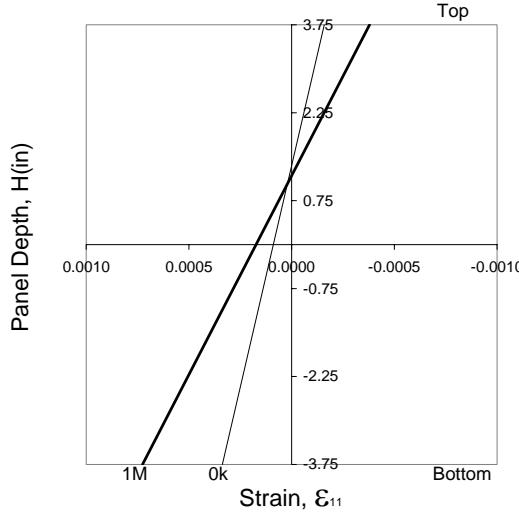
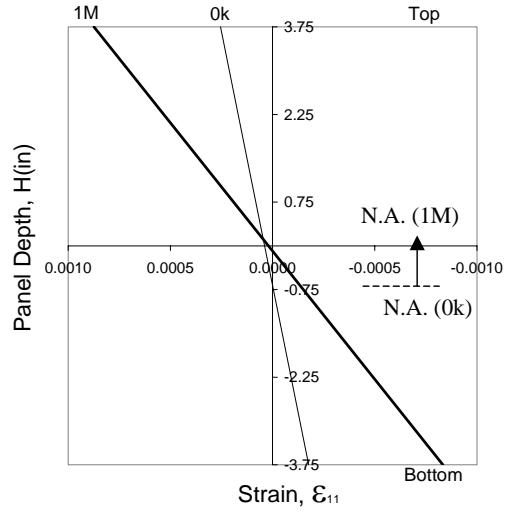
Figure 7-24 Strain profiles in Span 2

Figure 7-24 indicates that, near the interior riser, the top face was carrying less load than the bottom face at the initial static test and that the two faces were carrying the same amount of load at 1,000,000 cycles. This indicates that the bottom face could have delaminated after the fatigue load cycles.

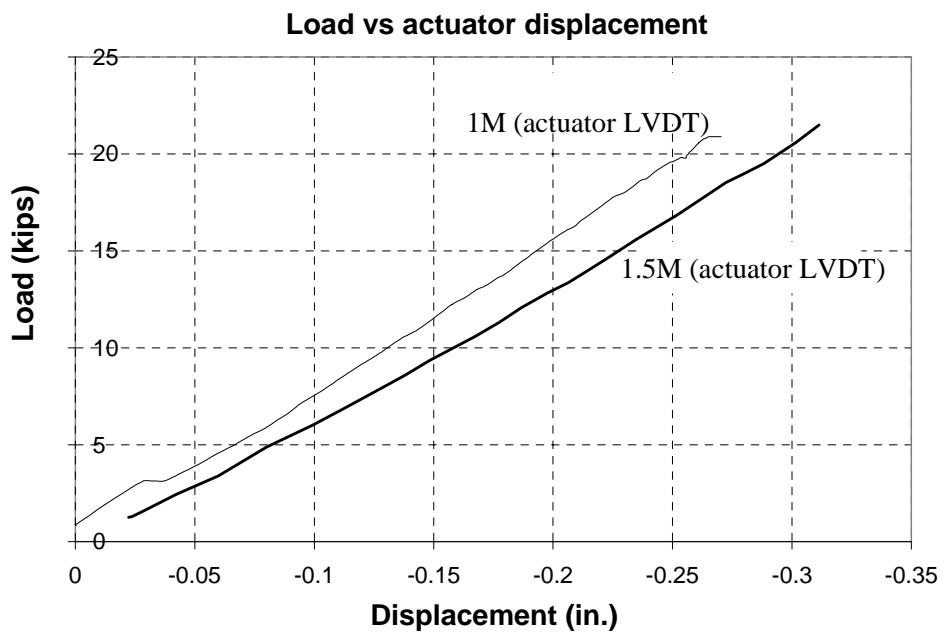
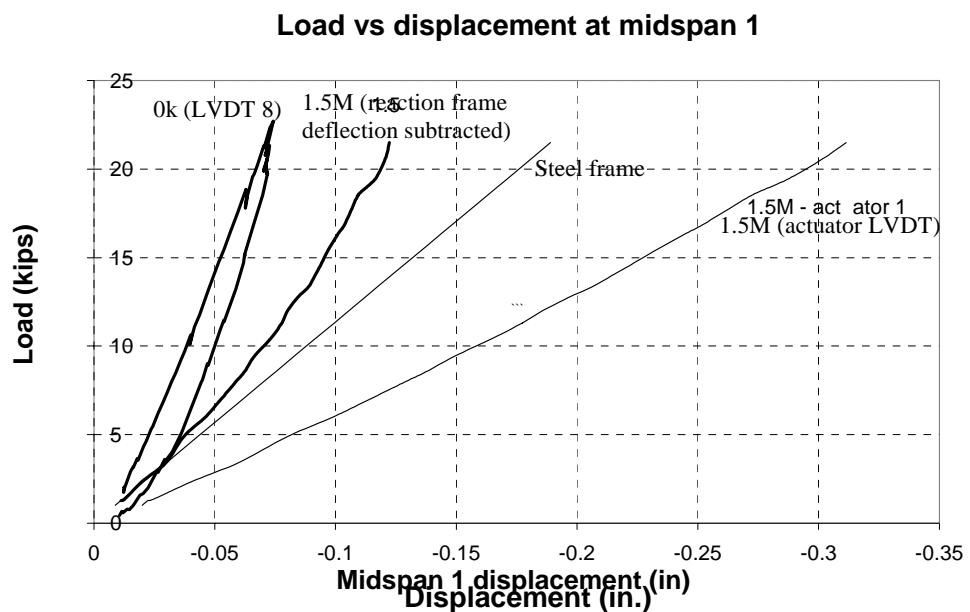
At 1,500,000 cycles, Span 1 started emitting a strong noise. Then, a static test was performed to evaluate the panel behavior (Static Test 1.5M in Table 7-2). Figure 7-25(a) compares the static load-actuator displacement responses at 1,000,000 and 1,500,000 cycles. The figure does not represent the true flexibility of the panel because the actual displacement includes the flexibility of the steel reaction frame that supported the actuator as well as the support settlements at the risers. The graph is used only to show that the overall stiffness decreased with load cycles. Figure 7-25(b) shows the comparison of the adjusted displacement at the middle of Span 1 at 1,500,000 cycles (1.5M) and the LVDT 8 reading at the initial static test (0k). To find the adjusted midspan displacement, the stiffness of the steel frame is first evaluated by using the initial static test data. Then, using this stiffness the steel frame displacement is calculated and subtracted from the actuator displacement to find the adjusted midspan displacement at 1,500,000 cycles. As shown, the stiffness of Span 1 decreased with increasing loading cycles probably because of the local delamination of the upper face from the core.

Figure 7-25 Load-displacement curves for Span 1

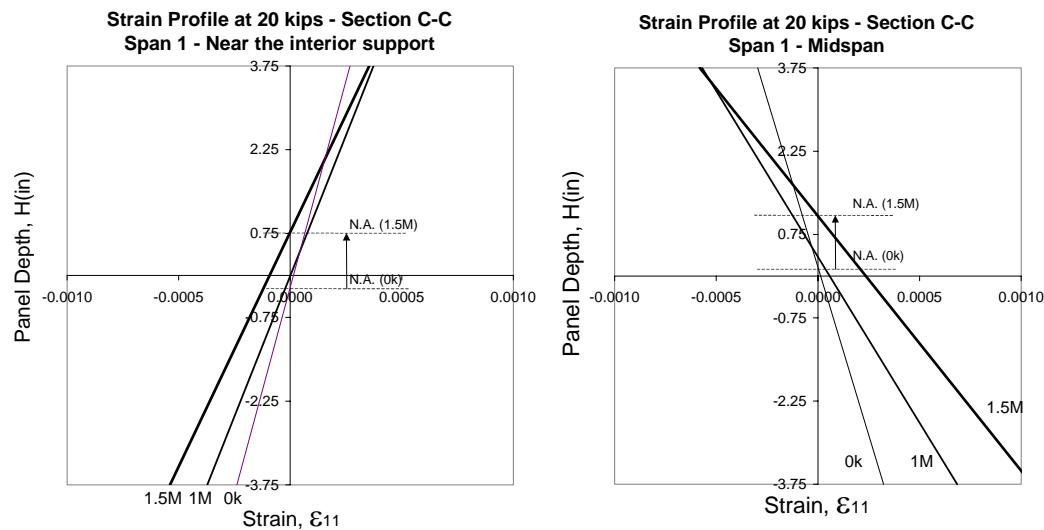
Figure 7-26 shows the load-strain curves at 0, 1,000,000 and 1,500,000 cycles. The strain profiles for Span 1 in Figure 7-27 indicate that the neutral axis moved upward from 0 to 1,500,000 cycles indicating that the lower face delaminated from the core.

Figure 7-27 Strain profiles at different loading cycles

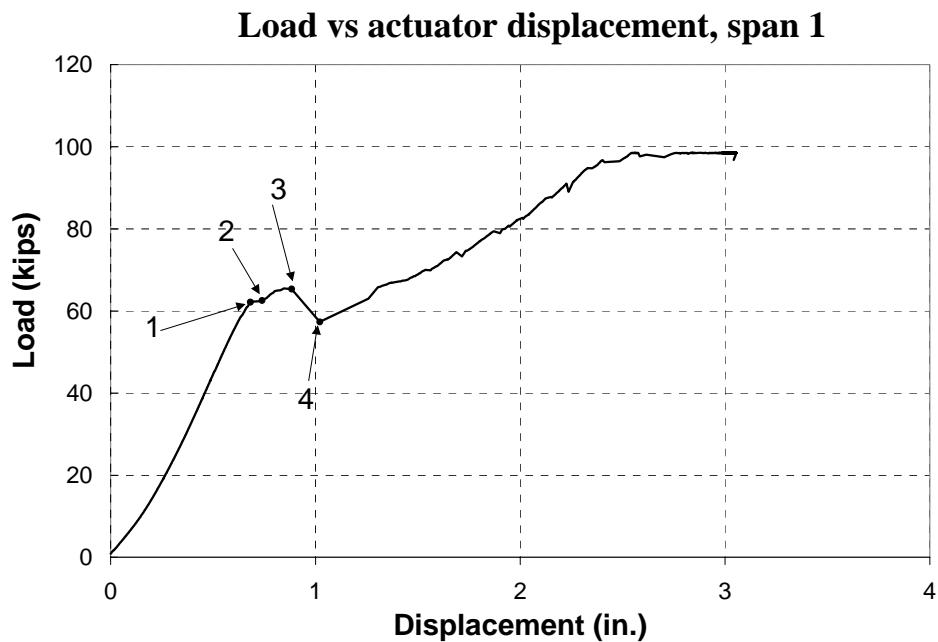
After the fatigue test was completed, the two spans were loaded one at a time up to 100 kips. Figure 7-28 shows the load-actuator displacement response for Span 1. The beams that were tested previously and the panel behaved differently after delamination. For three out of the four beams tested, the failure was brittle. One beam showed a ductile-like behavior because the upper face was not glued uniformly to the core and had progressive delamination. The latter is similar to the panel behavior. In the panel, a crack formed in the face-core interface near the loading plate when the maximum shear stress exceeded the interface shear strength and the crack propagated gradually causing a ductile-like failure.

Figure 7-28 Load- actuator displacement curve for Span 1

Between stages 3 and 4, the bottom face delaminated and the neutral axis shifted upward at the midspan and near the interior riser as shown in Figure 7-29 and Figure 7-30. The interface delamination was followed by a strong noise emission and a large load drop (stage 3 in Figure 7-28), which indicates a sudden energy release. A visible crack formed in the top face as shown in Figure 7-31. However, even when both faces delaminated, the panel did not collapse but was still carrying load because the damage was localized. This ductile-like behavior is desirable because it gives a warning prior to collapse.

After stage 4, as indicated in Figure 7-28, the load-actuator displacement curve shows small load drops, which were accompanied by noise emissions during the test. This means that the delamination propagated during the test. The figure shows that the damage propagation decreases the panel stiffness.

After 1.5 million load cycles, Span 1 delaminated at a static load of 62 kips as shown in Figure 7-28. Under a load of 62 kips, the interface shear stress in the constant shear zone of Span 1 is estimated to be 164 psi according to the FEA.

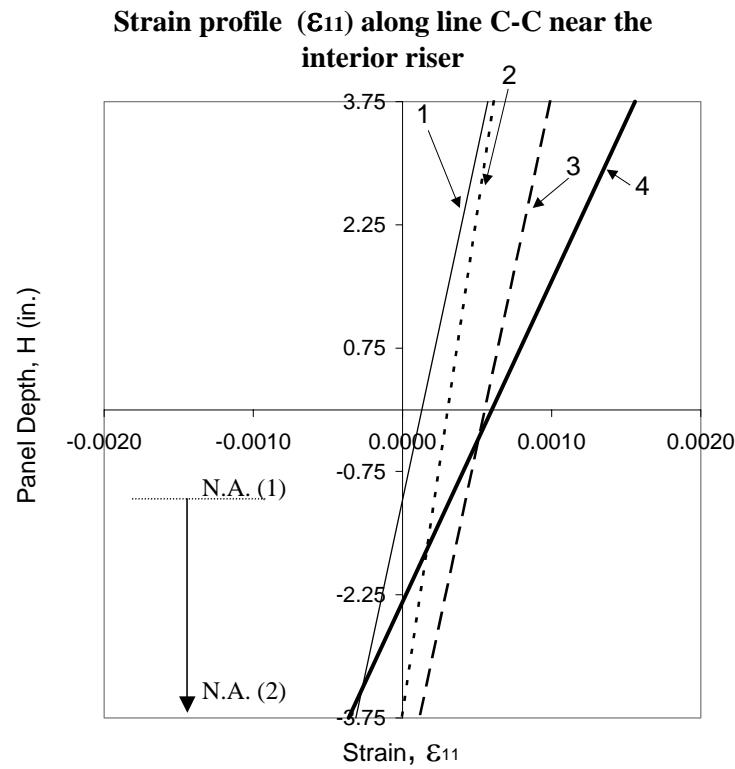
The strain profiles for Span 1 at different loading stages, 1, 2, 3 and 4 in Figure 7-28, are shown in Figure 7-29 and Figure 7-30. Both strain profiles show that the neutral axis moved downward between stages 1 and 2. This response indicates that the top face delaminated from the core.

Figure 7-29 shows that the strain at the bottom face near the interior riser was zero at stage 2, and the strain became positive at stage 3. Furthermore, at stage 3, the neutral axis near the interior riser was outside of the cross section. This is possible only if there was a horizontal tensile force acting on the panel (see Figure 7-18), which was probably caused by the anchor bolts as explained earlier. Figure 7-30 indicates that between stages 2 and 3, the neutral axis at midspan moved upward confirming that there was a horizontal force acting on the panel.

Figure 7-29 Strain profiles in Span 1 near the interior riser at 1,500,000 cycles

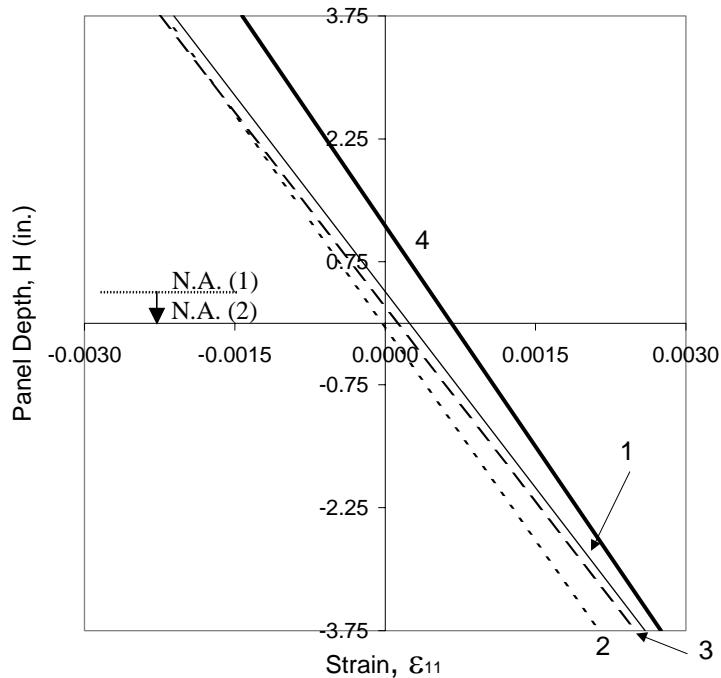
Figure 7-30 Strain profiles at the middle of Span 1 at 1,500,000 cycles

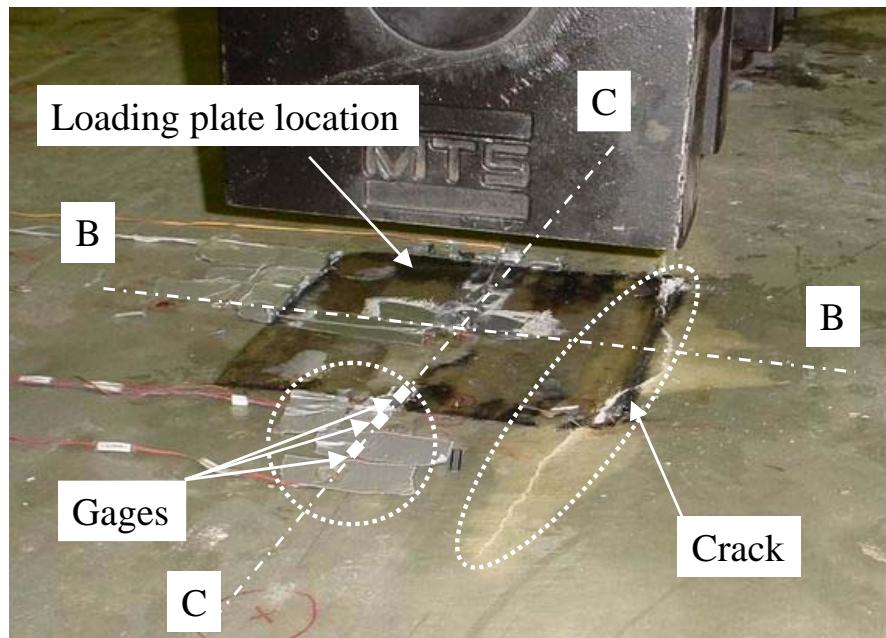
Figure 7-31 Crack located outside the loading plate in Span 1

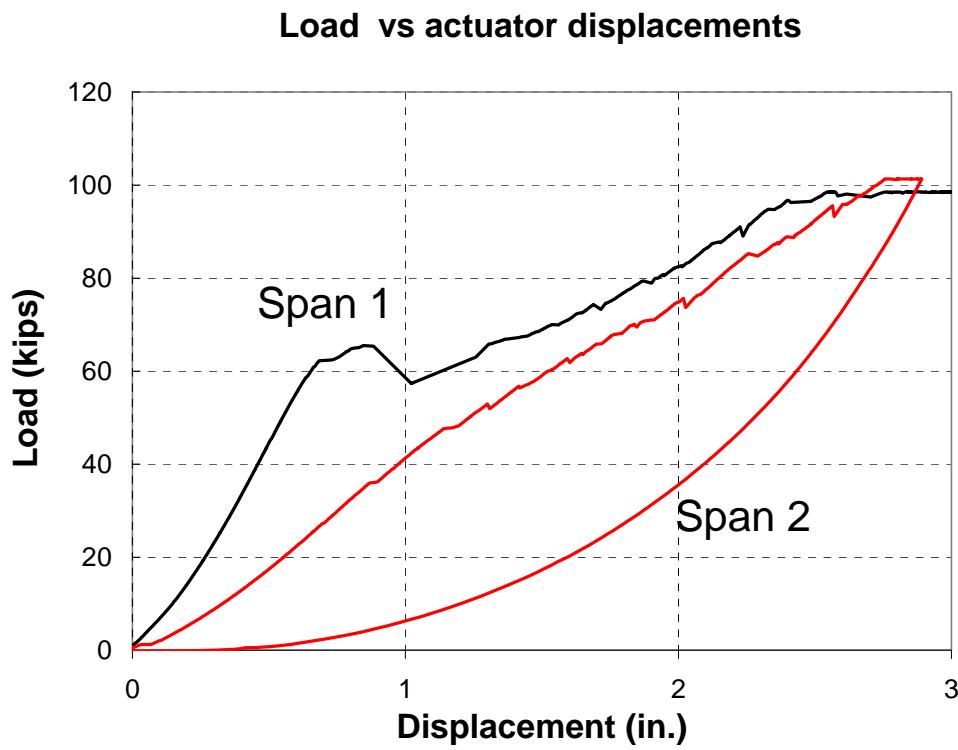
Figure 7-32 shows the load – actuator displacement curves for both spans. The load – actuator displacement for Span 2 does not show as large a load drop as for Span 1. Probably, the delamination of both faces occurred during the fatigue test, and for this reason, the curve does not show a sudden large load drop. This prior damage caused stiffness reduction as shown in Figure 7-32. The unloading branch indicates that there was a permanent plastic deformation when the panel was completely unloaded.

Figure 7-32 Load – actuator displacements for Span 1 and 2
